**FRENCH RIVER BASIN
LEICESTER, MASSACHUSETTS**

**STILES RESERVOIR DAM
MA 00983**

**PHASE I INSPECTION REPORT
NATIONAL DAM INSPECTION PROGRAM**

APRIL 1979

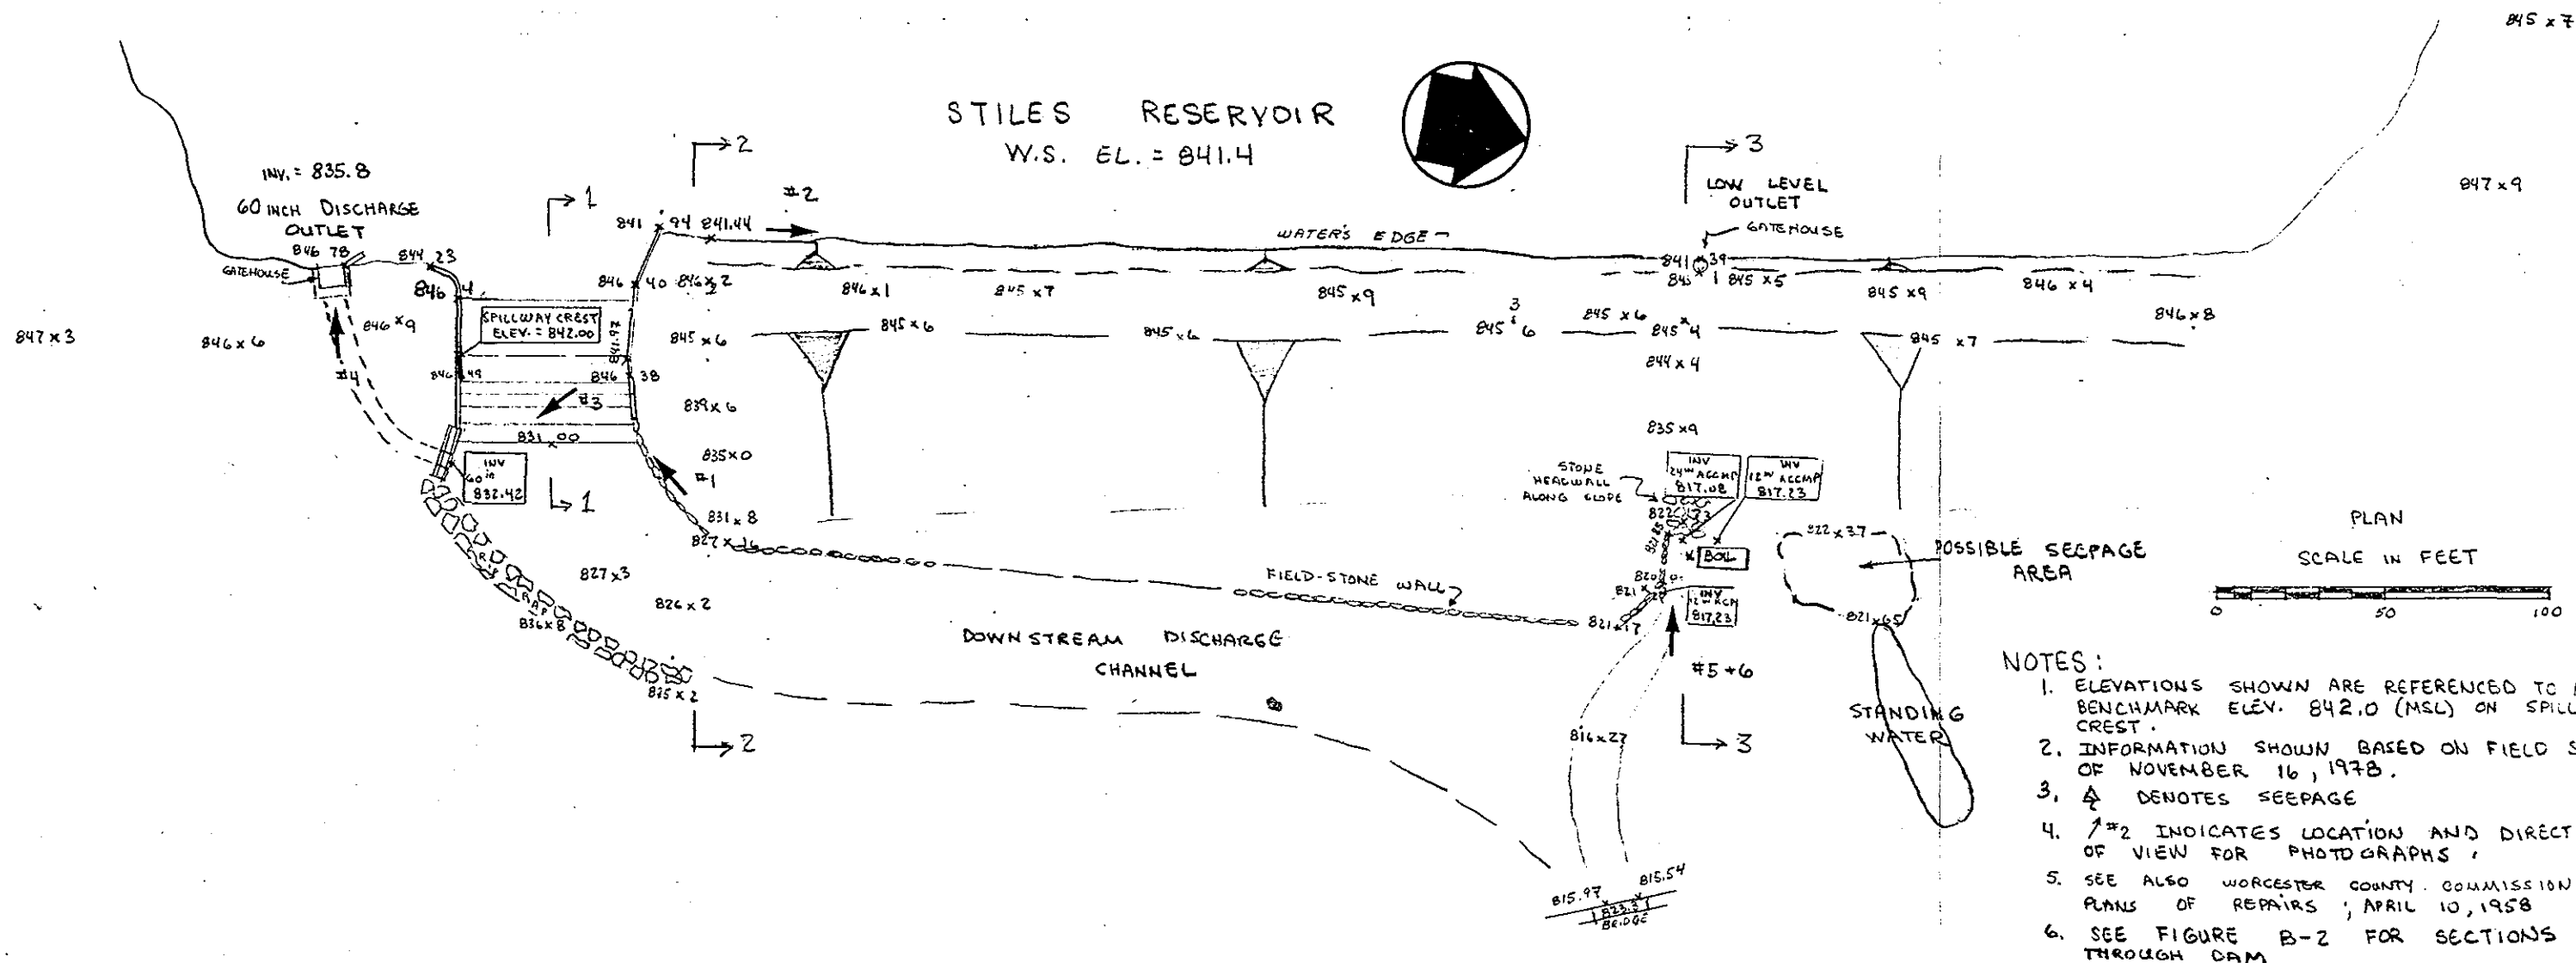
STILES RESERVOIR DAM

Riprap on the upstream slope appeared to be in fair condition. Some slight depression along the crest at the downstream side was noted as well as some small holes less than 12 inches in diameter and 6 inches deep. There were trees and small brush along some areas of the downstream slope. The toe of the dam had many trees and saplings growing. A large area of standing water was noted in the downstream area to the north of the outlet discharge channel (see Figure B-1).

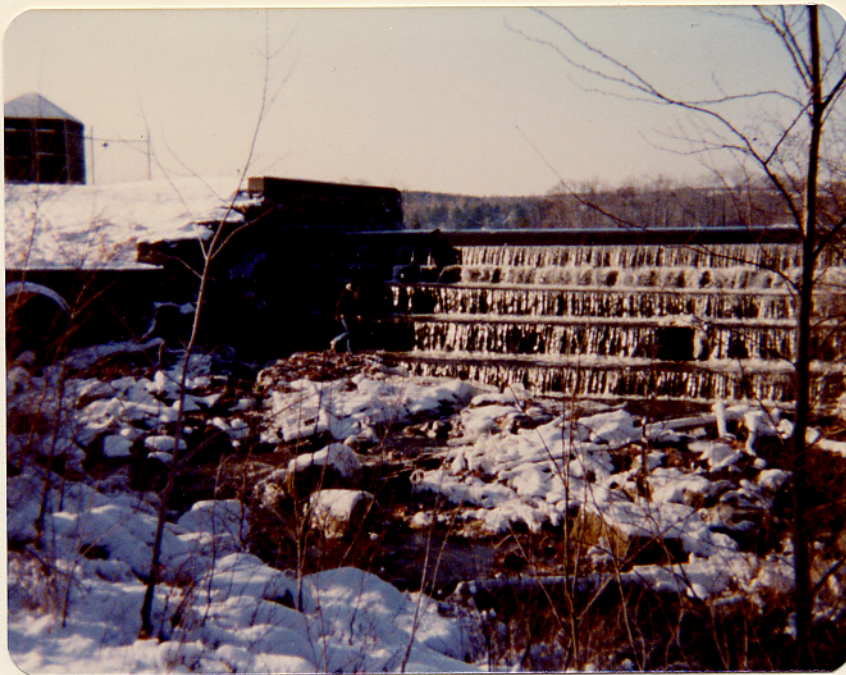
- c. Appurtenant Structures. The 50-foot long spillway and stepped cascade appeared to be in fair condition except for the leak previously noted. Small trees were growing within the discharge channels. In addition, the channels contained some small boulders.

- d. Visual Observations. The spillway appears in good condition except for the leak within the south abutment. The training walls have been repaired in the past and consist of concrete and mortared stone masonry. There is a concrete cap on top of the walls. Some cracks at the joints of the stone wall were noted.

NO. 1 VIEW OF SPILLWAY FROM DOWNSTREAM AREA

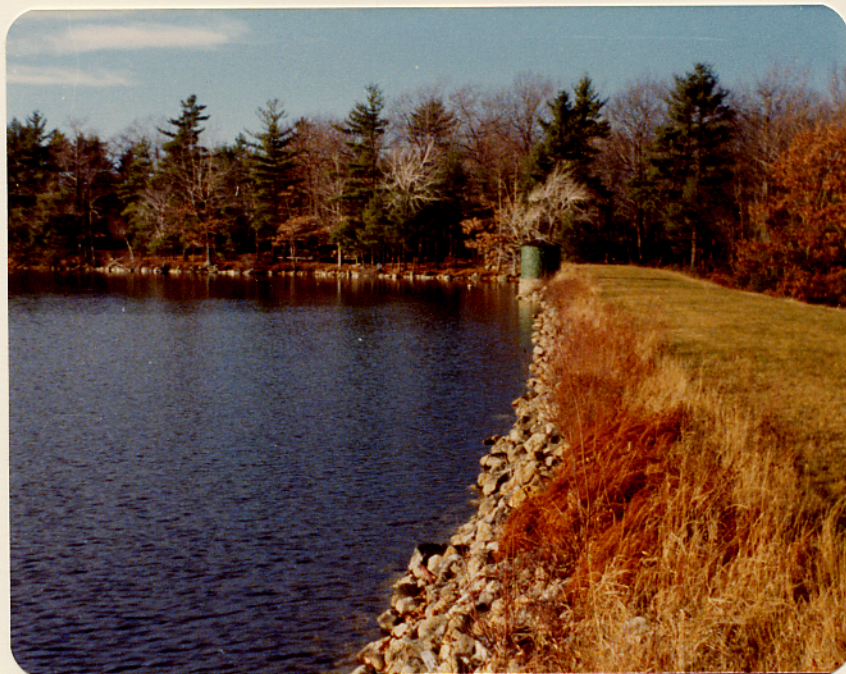
NO. 2 VIEW OF UPSTREAM SLOPE

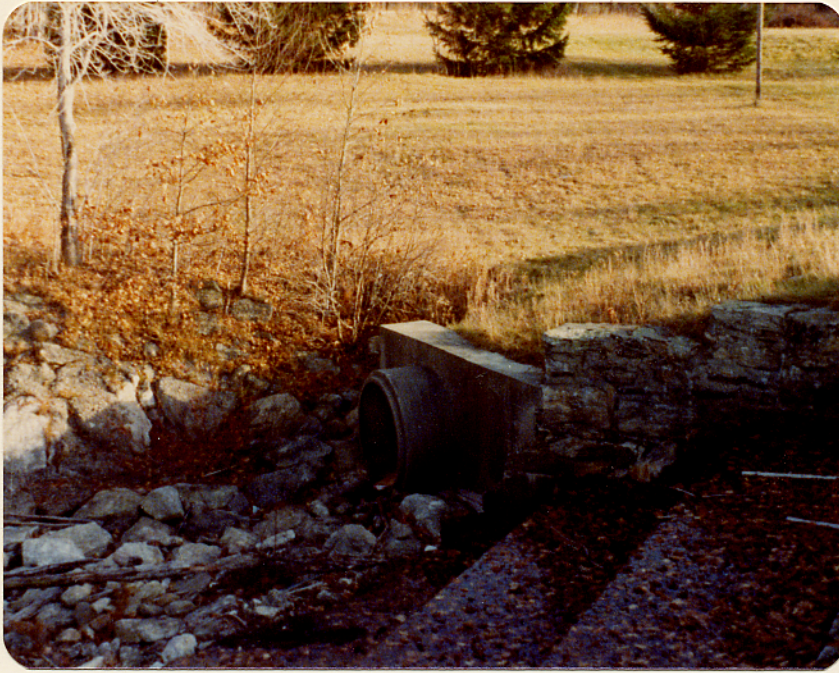
The 60-inch gate and conduit appeared in fair condition. The gate was clogged with a piece of debris so the gate could not be fully closed and was leaking. The gate however is in operable condition and the mechanism appeared well maintained.

NO. 3 VIEW OF GATED DISCHARGE PIPE AT SPILLWAY

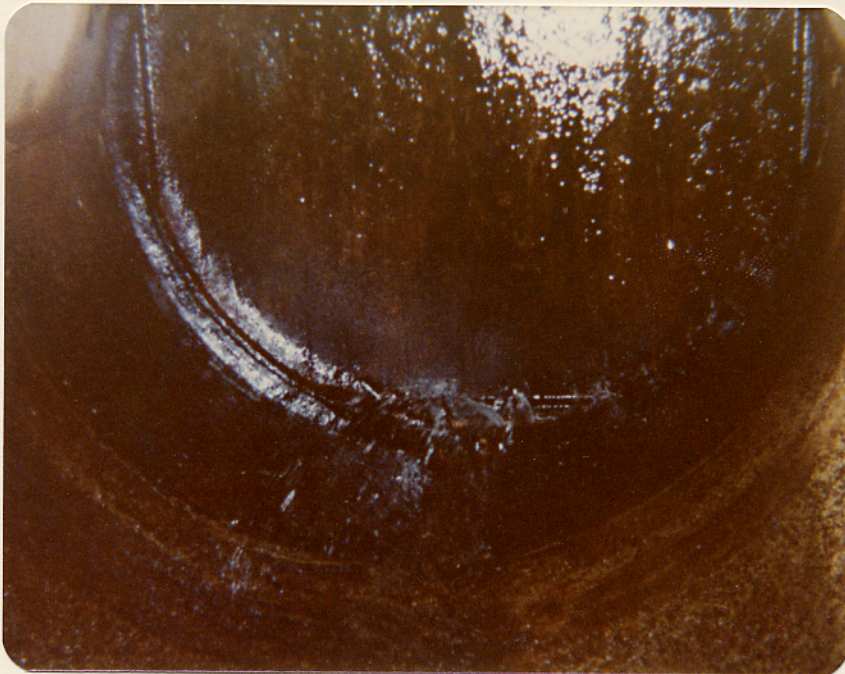
NO. 4 VIEW OF DOWNSTREAM SIDE OF SLUICE GATE AT SPILLWAY

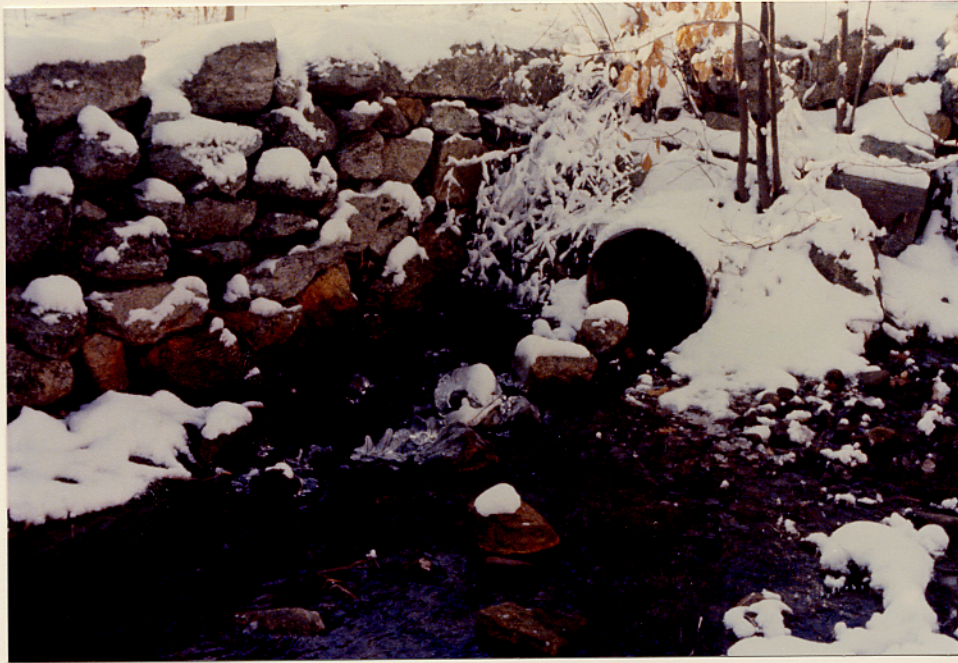
- b. Dam. Stiles Reservoir Dam is an earthfill dam that has a history of leakage since at least 1923. Past inspection reports have documented various leaks at the dam. At the time of the Phase I inspection, there were three areas of leakage noted. A serious and apparently perennial leak occurs in the vicinity of the low-level outlet. Water, estimated flowing at 50 to 70 gpm is discharging immediately to the south of the 24-inch low-level outlet from beneath the dam. The water appears to be clear, however. Several feet downstream of the outlet and within the discharge channel, a small, approximately 6-inch diameter, upward seepage zone was noted. Water flowing to the surface did not appear to be dislodging soil particles. A second leak was noted within the south spillway abutment near the toe of the dam. A small cavity was noted between the training wall and earth abutment. A third small leak was noted flowing beneath the 60-inch concrete conduit.

Those factors which are considered of major importance to the stability of the dam include the three areas of leakage observed during the inspection. Severe leakage through the dam at the area of the low-level outlet appears serious. Also of concern is the leakage at the foot of the south training wall to the spillway. The leakage beneath the 60-inch diameter outlet also presents a hazard. The upward seepage condition at the downstream toe within the low-level outlet discharge channel could present a hazard to the stability of the dam.

NO. 5 VIEW OF DISCHARGE AT OUTLET PIPE

- a. Operating and Maintenance Procedures. The dam and appurtenant structures are not adequately maintained. It is recommended that the Owner accomplish the following:
- (1) Immediately open the 60-inch outlet and drain the pond to the invert elevation (El 835.2).
 - (2) Repair the leaks indicated in Section 3, Visual Inspection, based on recommendations by a qualified consultant.
 - (3) Clear the trees and brush from the dam and within 50 feet of the downstream toe. The discharge channel should also be kept clear of trees and brush.
 - (4) Repair the low-level outlet.
 - (5) Monitor the joints of the 60-inch diameter outlet for evidence of further movement and repair.

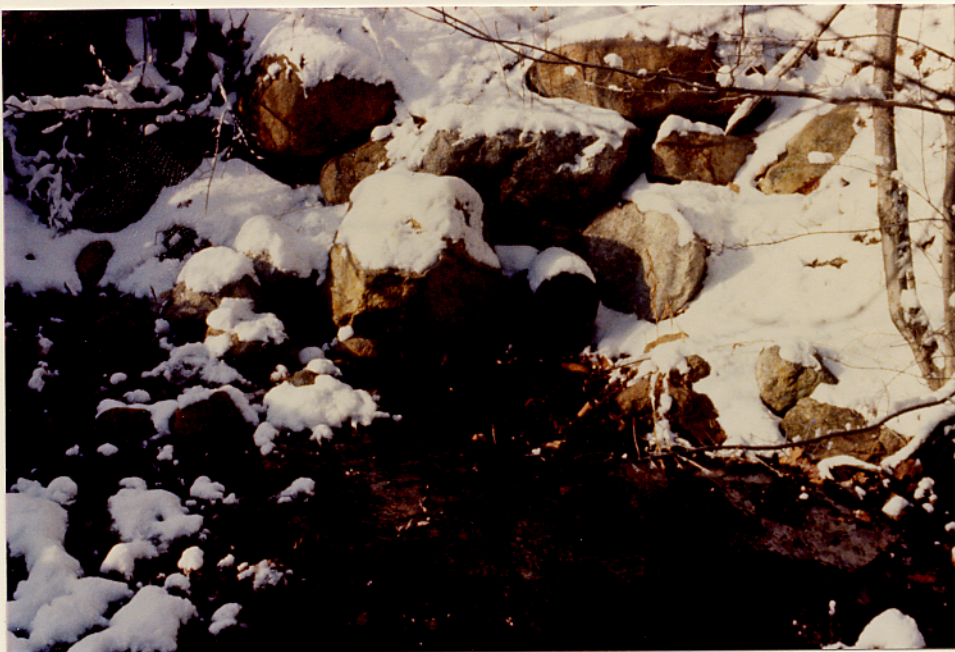
Unusual Embankment or Downstream Seepage	Leak in downstream toe within area of 15" outlet 50-70 GPM (estimated)
Piping or Boils	Upward flow of water in seepage area
Foundation Drainage Features	Unknown
Toe Drains	Partial 12-inch diameter
Instrumentation System	None

NO. 6 VIEW OF DISCHARGE IN VICINITY OF OUTLET PIPE

7.2 Recommendations. In view of the concerns over the continued performance of the dam, it is recommended that the Owner employ a qualified consultant to investigate and evaluate the leakage and upward flow of water at the dam within the downstream toe area and spillway. In the interim, the 60-inch outlet should be opened to reduce the pressure head within the embankment and foundation. The consultant should also perform a detailed hydraulic/hydrologic analysis to evaluate the spillway capacity.
